POSTFLIGHT EVALUATION OF ATLAS-CENTAUR AC-5

(Launched March 2, 1965)

Centaur Project Office

Lewis Research Center
Cleveland, Ohio

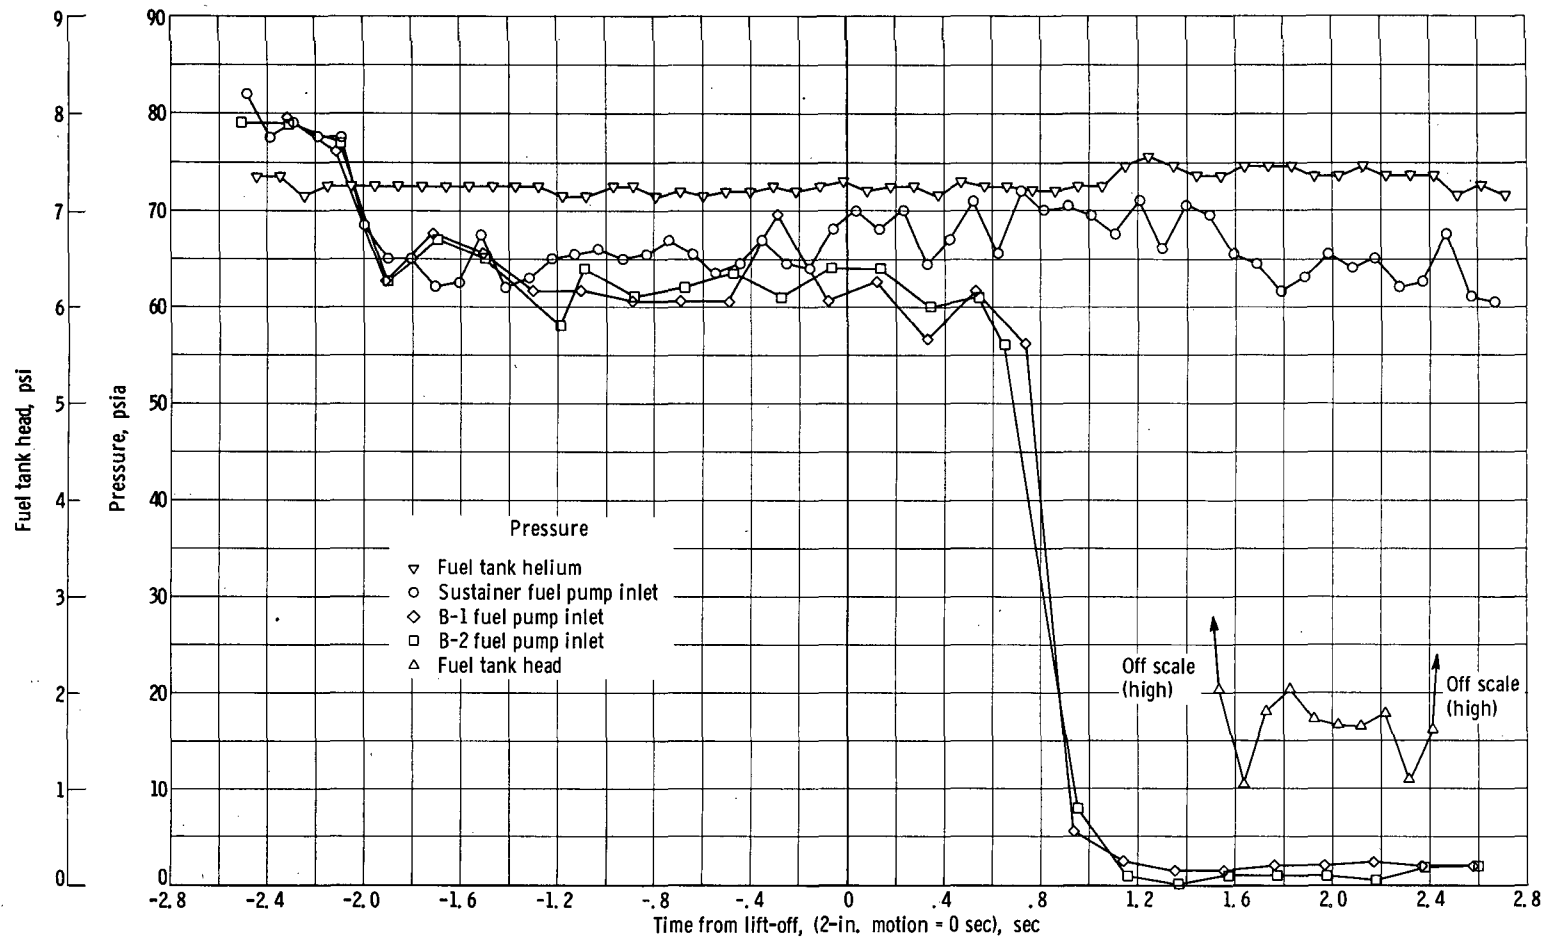
Duct blockage. - Hardware inspection of the pertinent areas uncovered no obstruction considered adequate to block fuel flow. It is highly doubtful that a foreign object could have so completely terminated flow as to result in the rapid pressure decay indicated in figure V-2.

Figure V-2. - Atlas fuel pump inlet and tank pressures as function of time from AC-5 flight data.

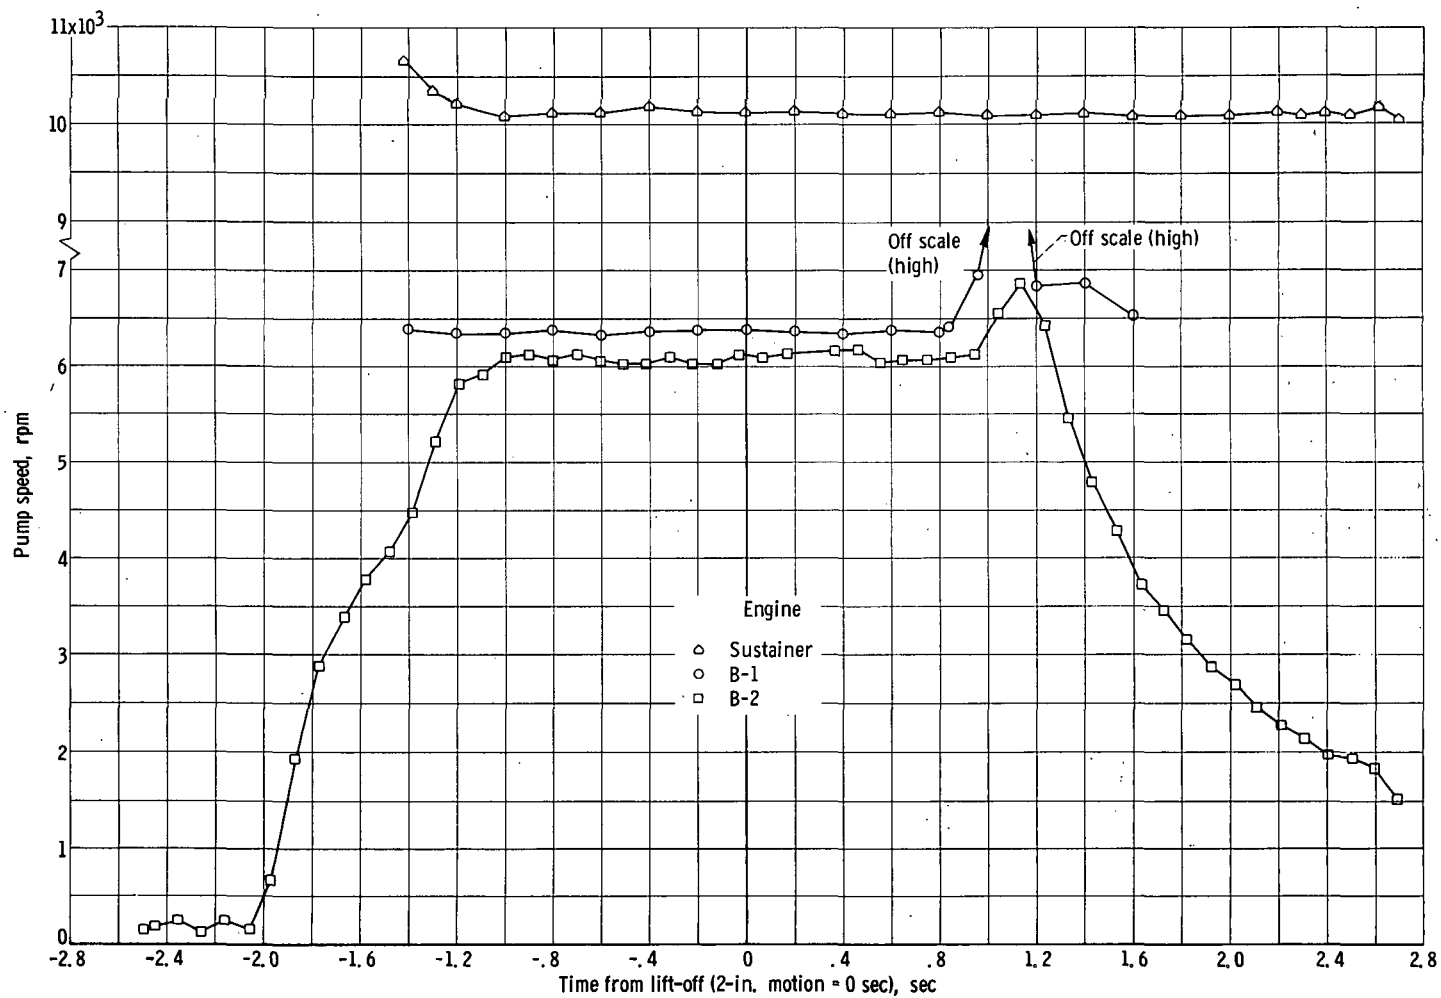
The B-1 turbopump started to overspeed from its normal speed of 6350 rpm at 0.8 second (see fig. V-5). The B-2 turbopump started to overspeed at 0.95 second with a value of 6150 rpm, reached a peak value of 6850 rpm at 1.1 seconds, and decayed to 1500 rpm by 2.7 seconds. The turbopumps initially oversped because the loss of fuel unloaded the system. The only discrepancies in the sustainer system and the booster LOX system performance (fig. V-6) are considered a result of the vehicle failure.

Figure V-5. - Atlas engine rpm as function of time for AC-5 flight.

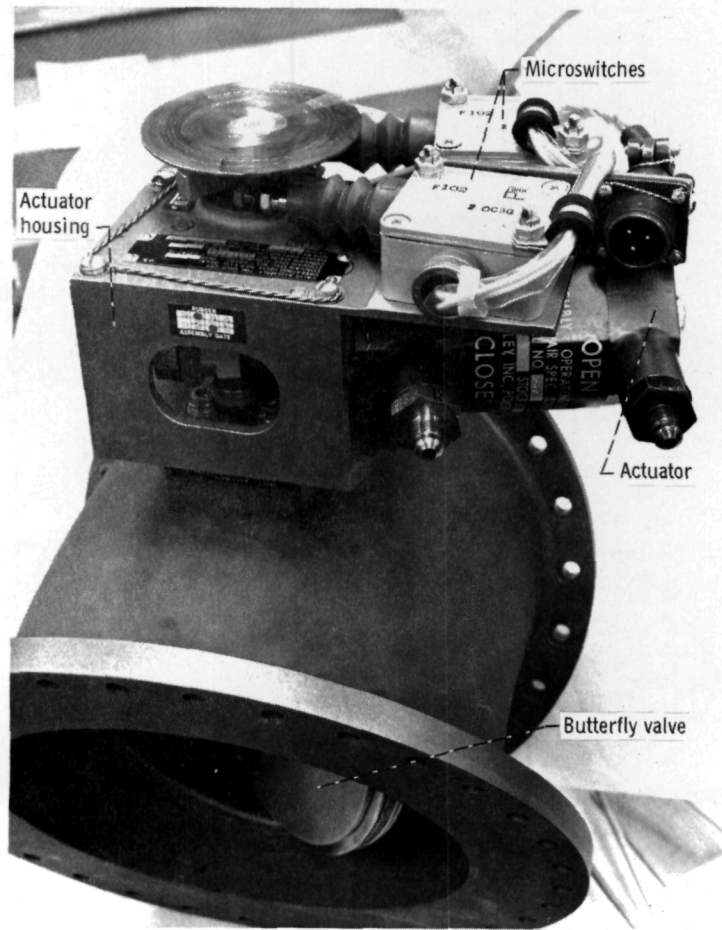
Figure V-8. - Booster fuel prevalue assembly. (Disk in upper left portion of figure installed for testing purposes only).

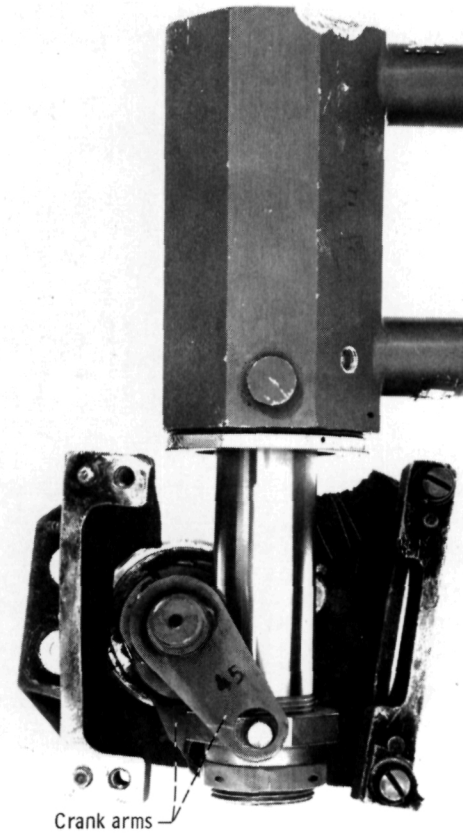
The AC-5 pre valve actuator was recovered, disassembled, and examined for failure analysis. Testing and examination of the components were compared with failure history reports on other actuators. The only significant anomaly was the presence of a foreign fluid behind the actuator piston. The fluid was analyzed and found to be a mixture of RP-1 fuel and "firex" water. Firex water was used to quench the flames after vehicle impact. The fluid is assumed to have entered the actuator following vehicle destruction.

Figure V-9. - Recovered AC-5 actuator and crank arm assembly. (Actuator in the open position).

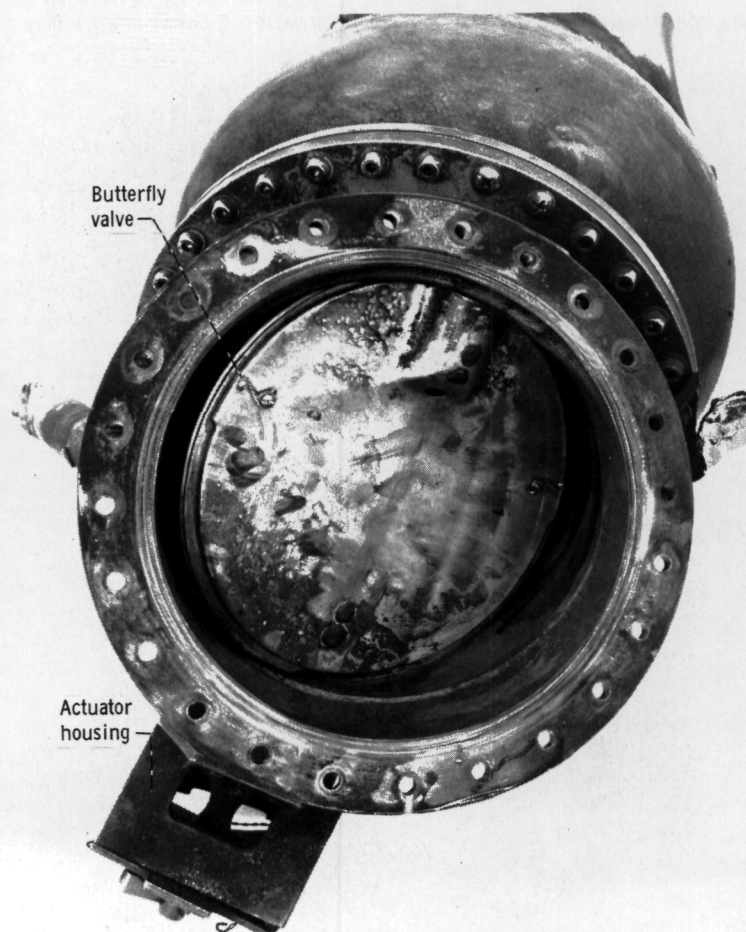
Prevalve. - Examination of hardware after the fire indicated that the pre-valve actuator was unlocked and the butterfly valve was near the closed position. Evaluation of data revealed there was no command given to close the pre-valve. Flow tests indicated the maximum torque that fuel flow can exert on the butterfly valve was approximately 260 inch-pounds. With the prevalve in the locked open position the minimum torque required to cause system failure was de-

Figure V-10. - Recovered AC-5 booster fuel pre valve. View looking into booster fuel pre valve (still assembled to staging valve) showing butterfly position.

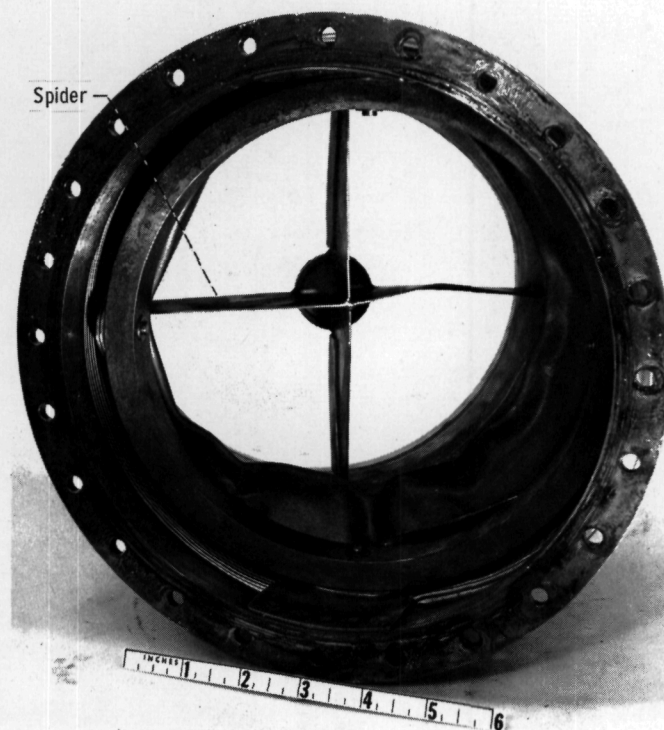
Figure V-II. - Rear view of recovered staging disconnect showing spider still intact.

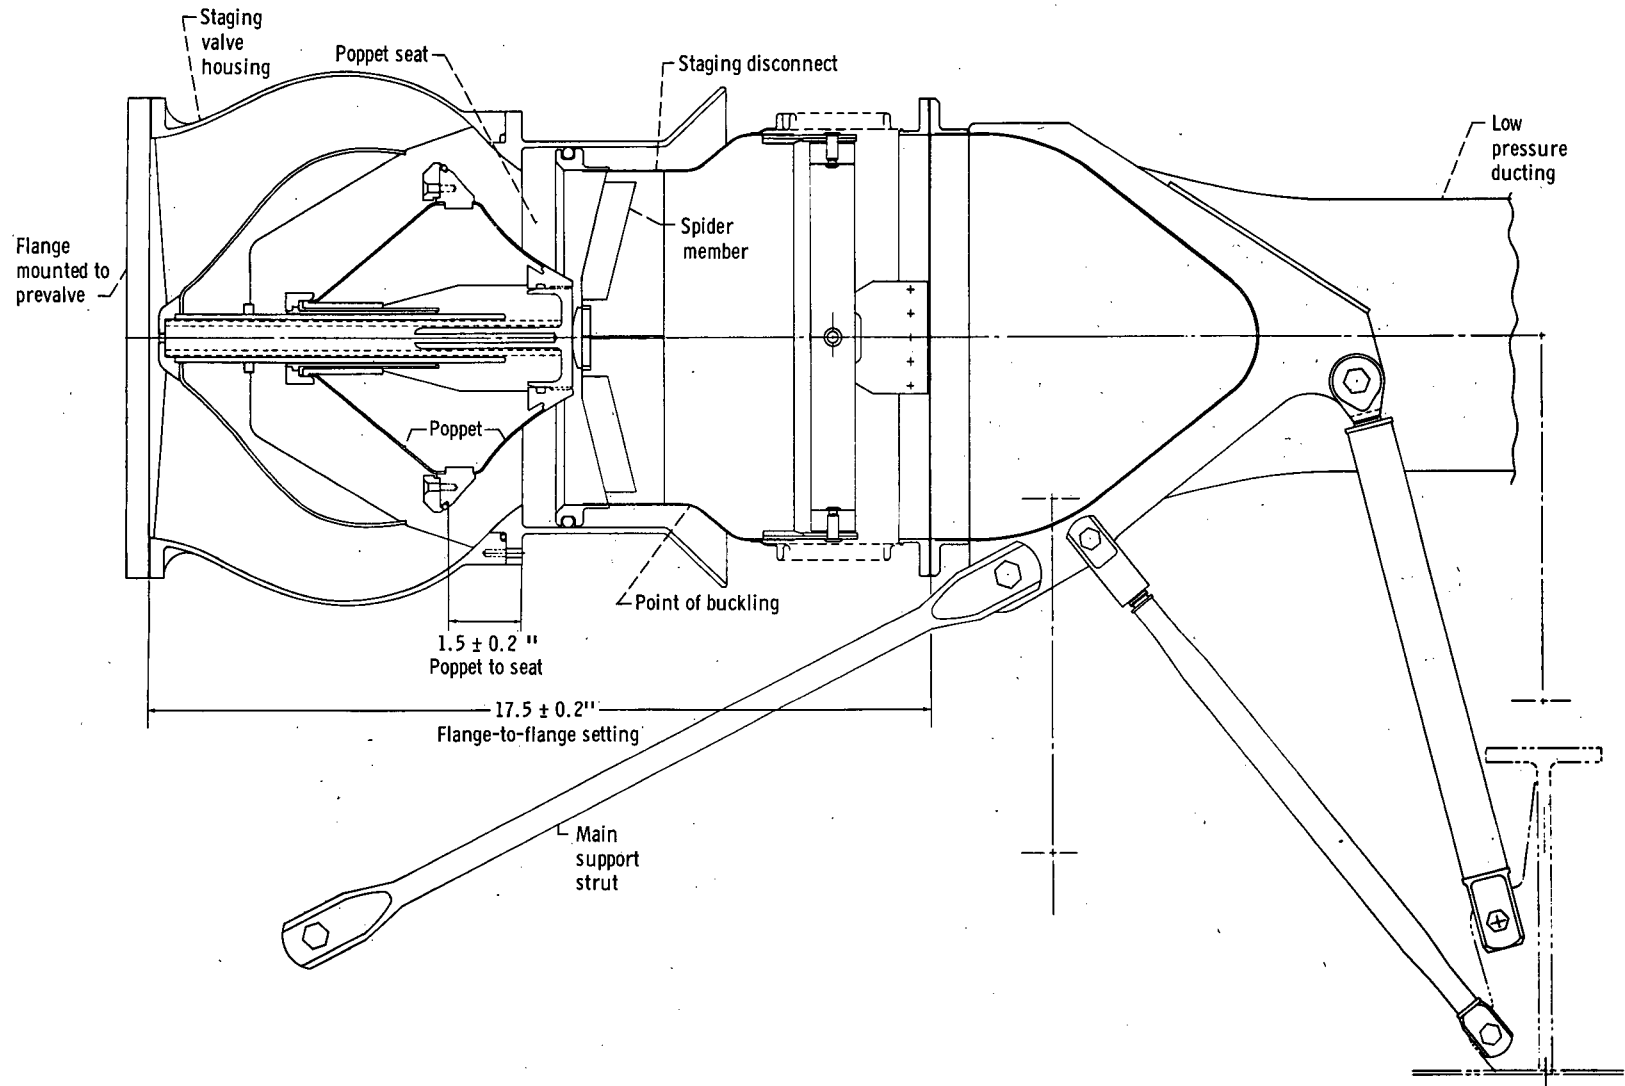
Closure of the staging valve can be accomplished by buckling of the spider member, buckling of the staging disconnect, failure of the main support, displacement of the booster structure, or combinations of these (see fig. V-12). Results of unpublished GD/C analysis have eliminated displacement of the booster structure alone as a possible failure mode. Investigations have been conducted to evaluate the remaining failure modes.

Figure V-12. - Schematic drawing of Atlas Fuel staging valve and staging disconnect.

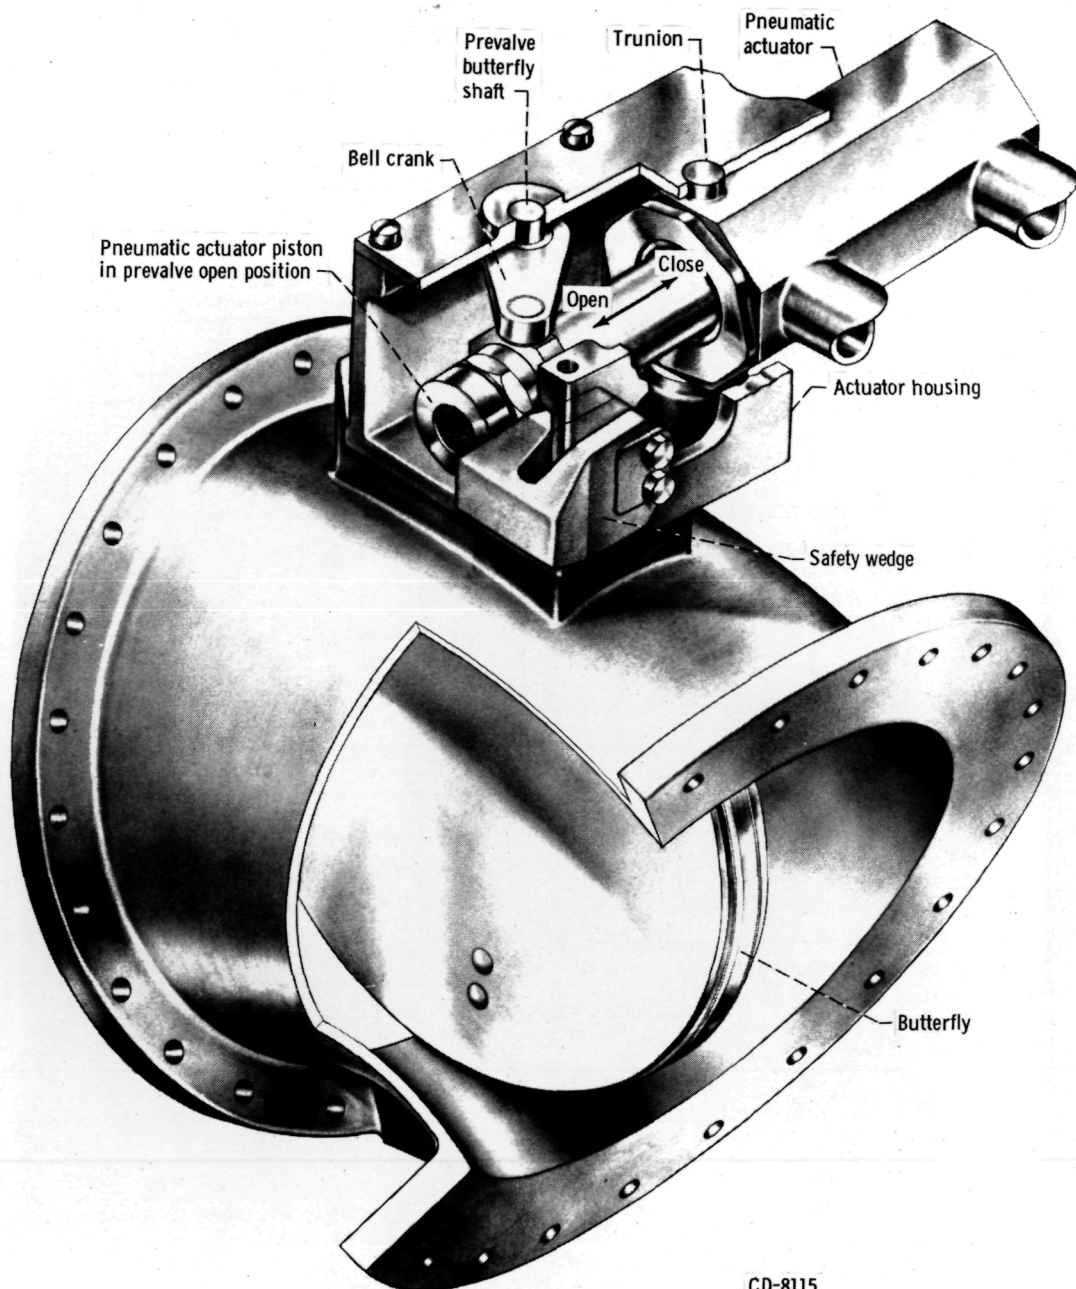
Figure V-14. - Interim fix safety-wedge design to prevent inadvertent closure of fuel preclude.

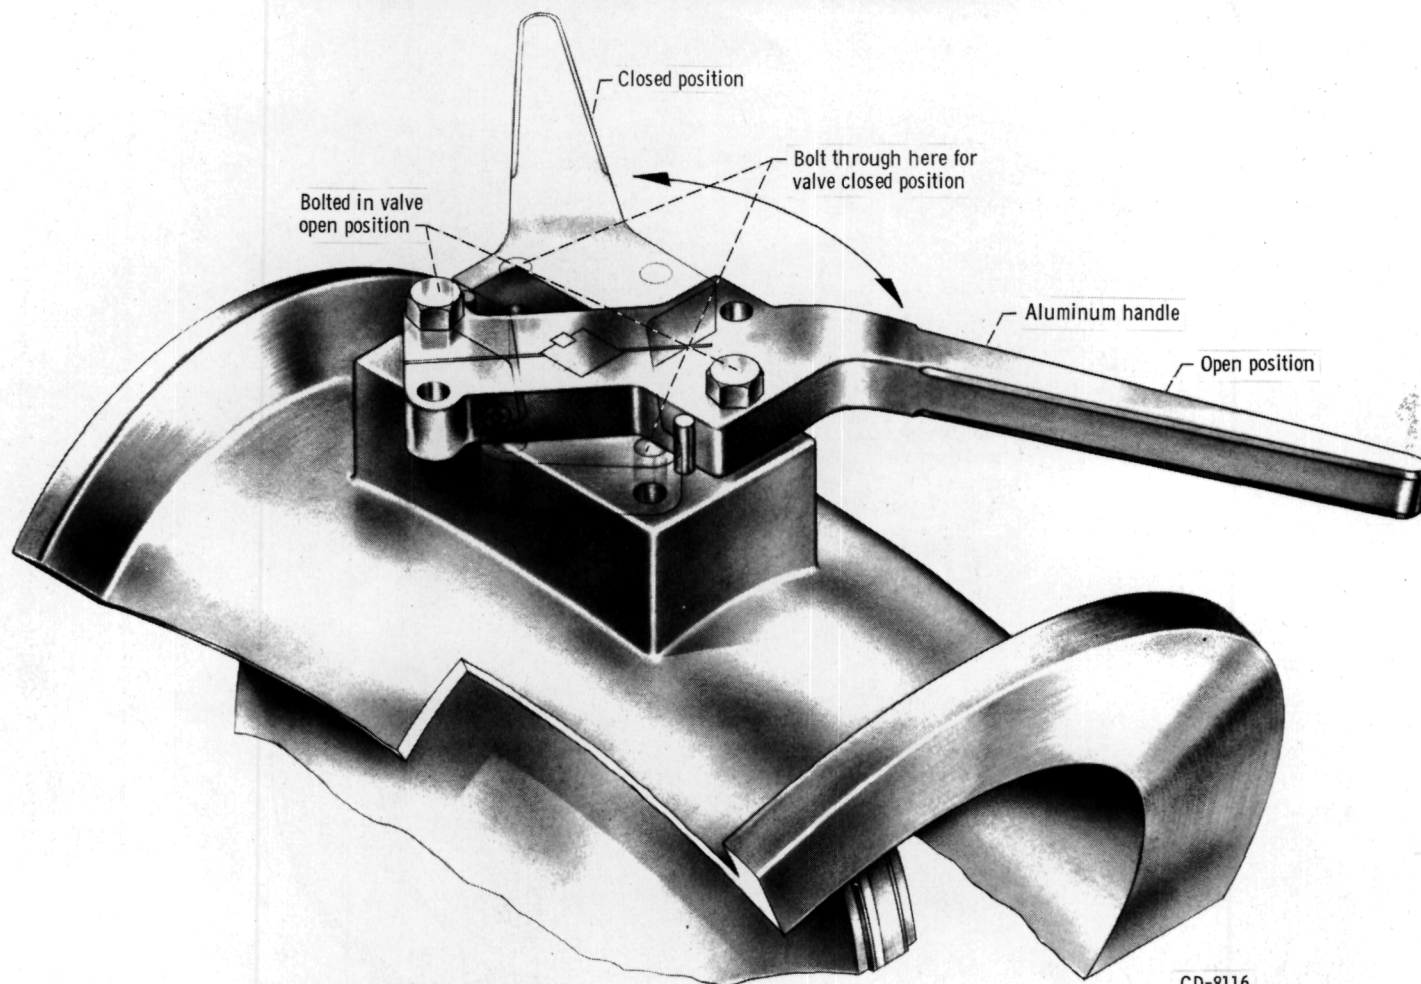
Figure V-15. - Schematic drawing of booster preclude manual actuator aluminum (6061-T6) handle.

Permanent fix: Design of a permanent modification of the prevalve actuator for the Atlas-Centaur consisted of substituting a manual handle on the butterfly shaft to replace the pneumatic actuator. The manual handle has the capability of being locked in the prevalve open and closed positions by two bolts either of which is capable of reacting fuel flow loads induced by the prevalve butterfly. Figure V-15 shows the details of this modification. In order to obviate similar failure of the sustainer fuel prevalve, remote pneumatic actuation on this valve was also deleted. This was replaced by an Atlas series "E" manually operated prevalve. An improved locking device is to be incorporated to assure positive locking in the open position by means of a clamping bracket. This device is illustrated in figure V-16. To establish the load-carrying capability of the various elements of the prevalve system, a static load test was accomplished. The results of this test are shown in figure V-17. The load was applied to the butterfly shaft with a moment arm of 24 inches, subjecting the shaft to a static torque. This torsion was transmitted to

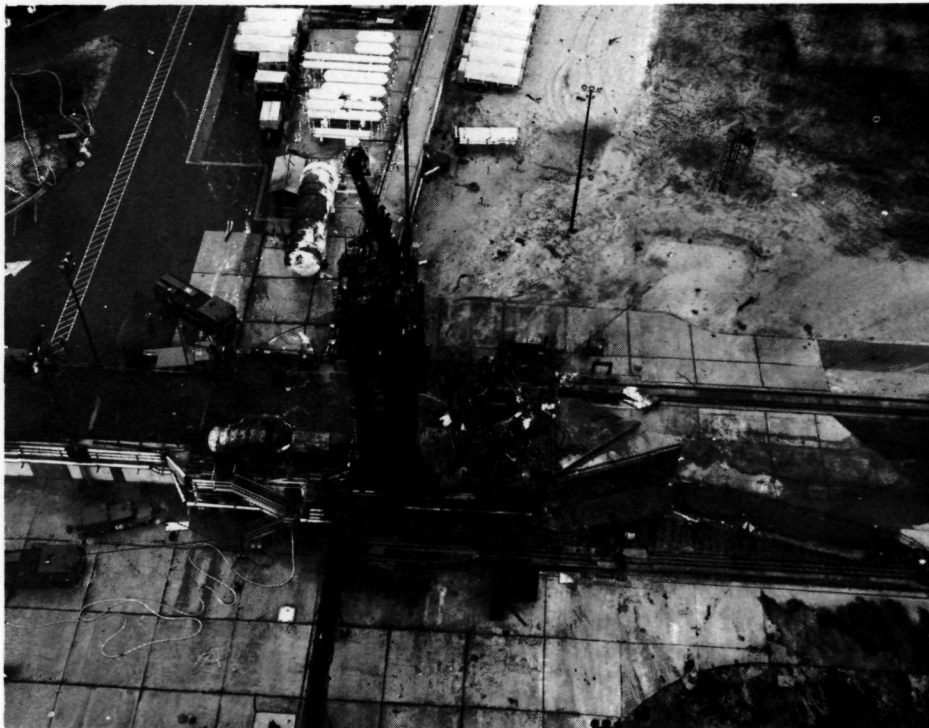
Figure XII-1. - Aerial view showing general damage to pad area.

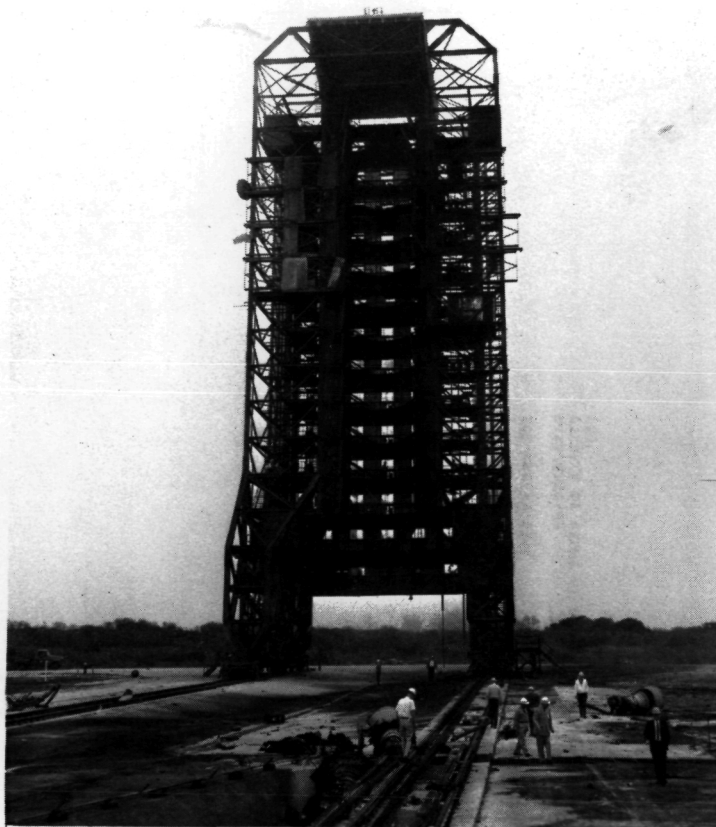
Figure XII-2. - View of service tower showing damage to Fiberglass panels.

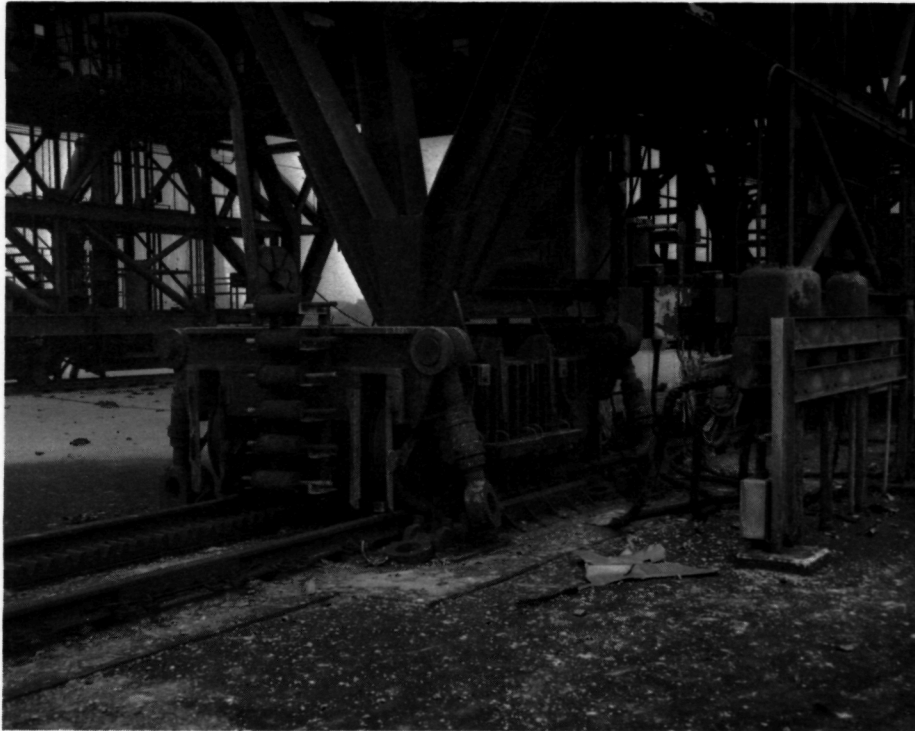
Figure XII-3. - View of southeast corner of service tower showing heat damage to electrical wiring.

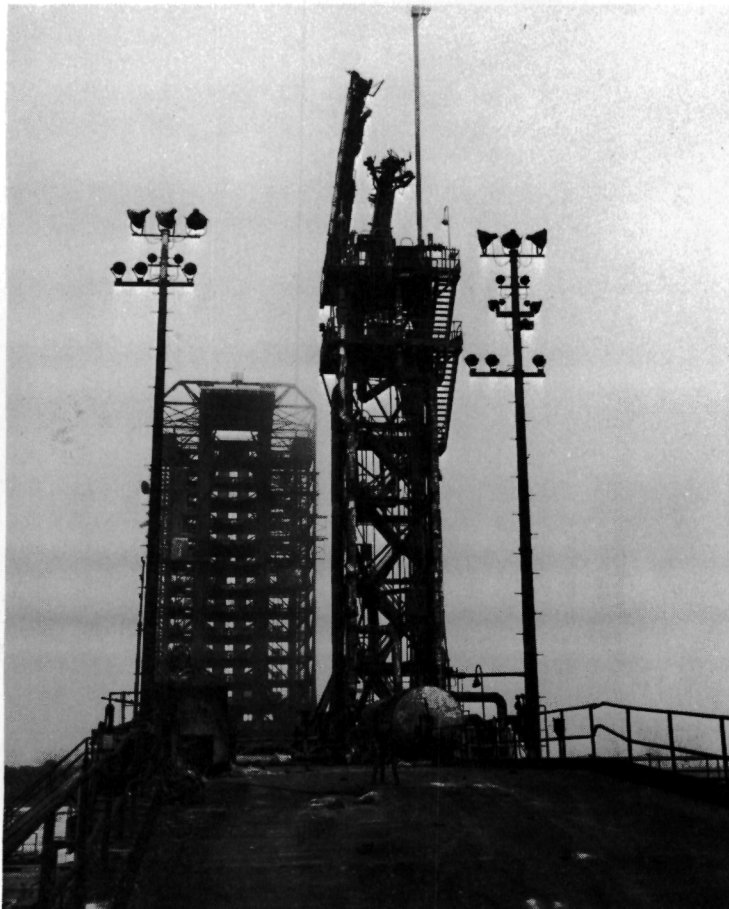
Figure XII-4. - View from ramp showing general damage to umbilical tower.

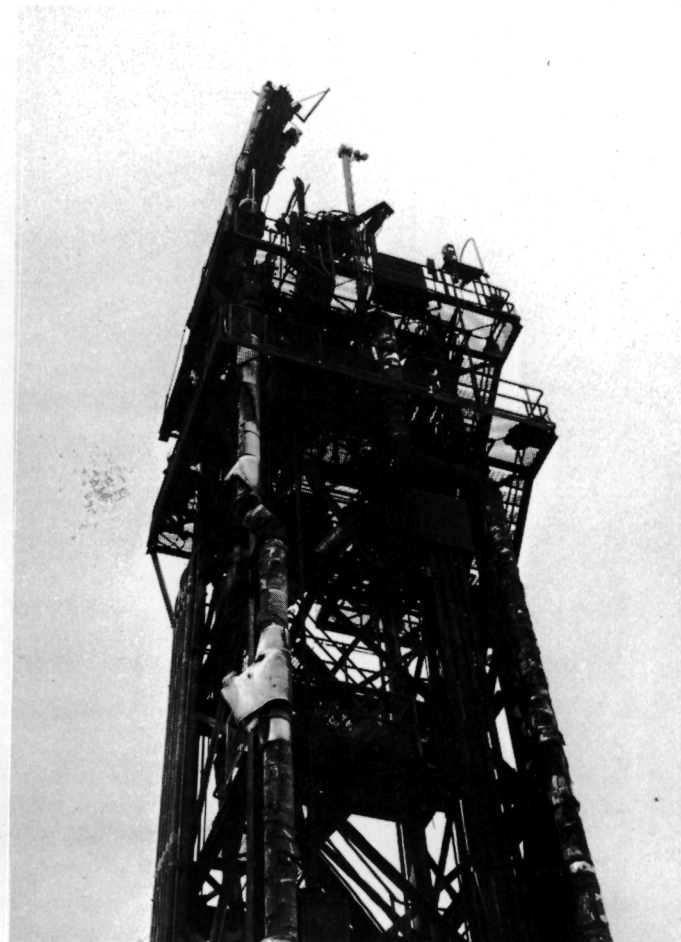
Figure XII-5. - Closeup view of umbilical tower showing damage to air-conditioning ducts.

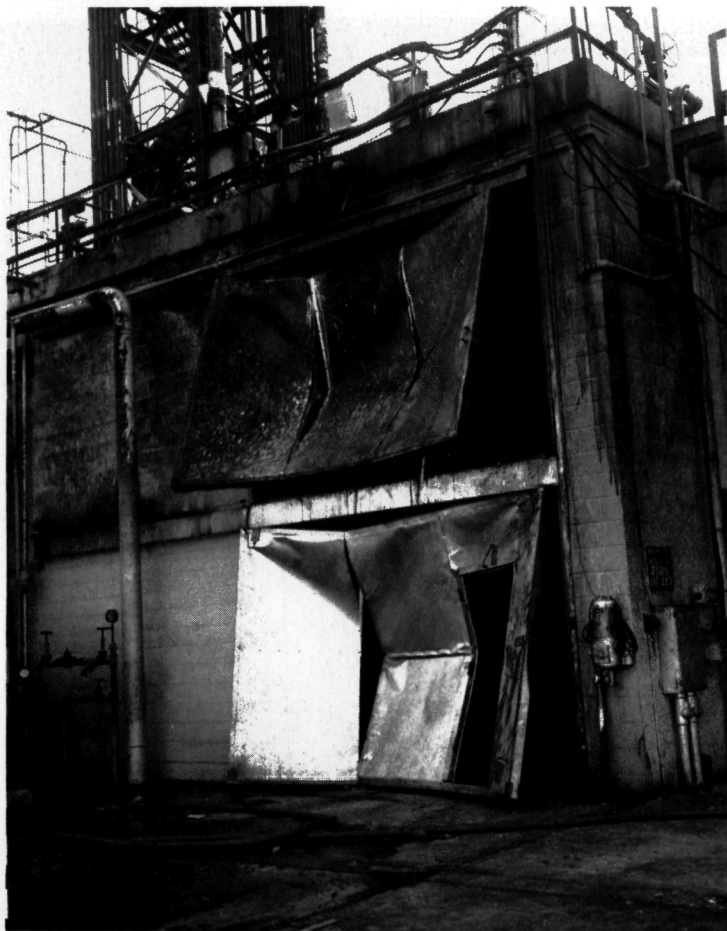
Figure XII-6. - View of launch and service building showing damaged doors.

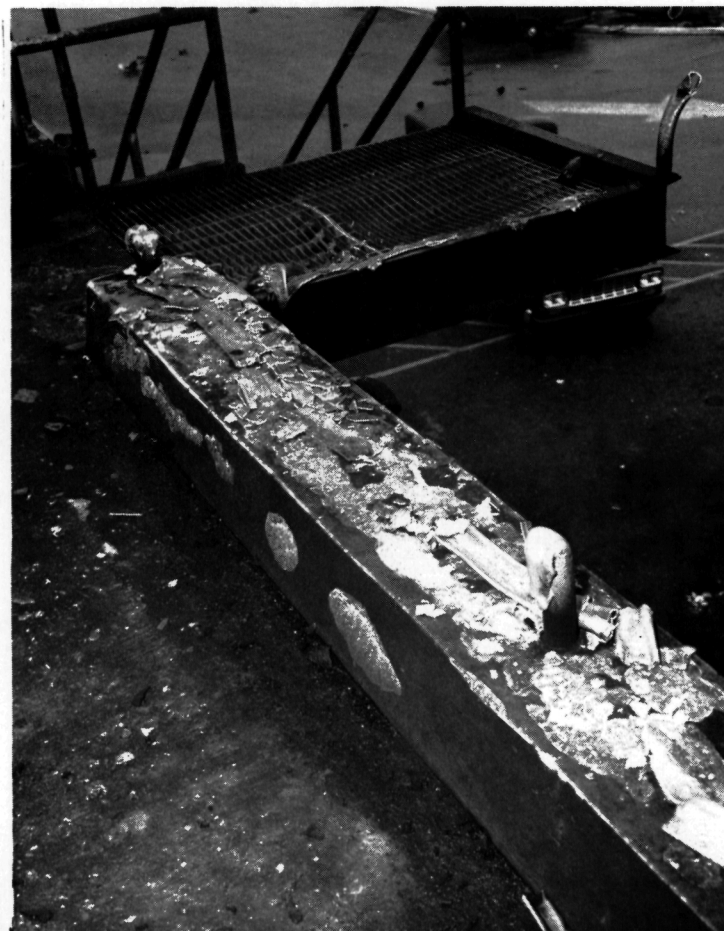
Figure XII-7. - View at top of ramp showing melted aluminum handrails and damage to grating.

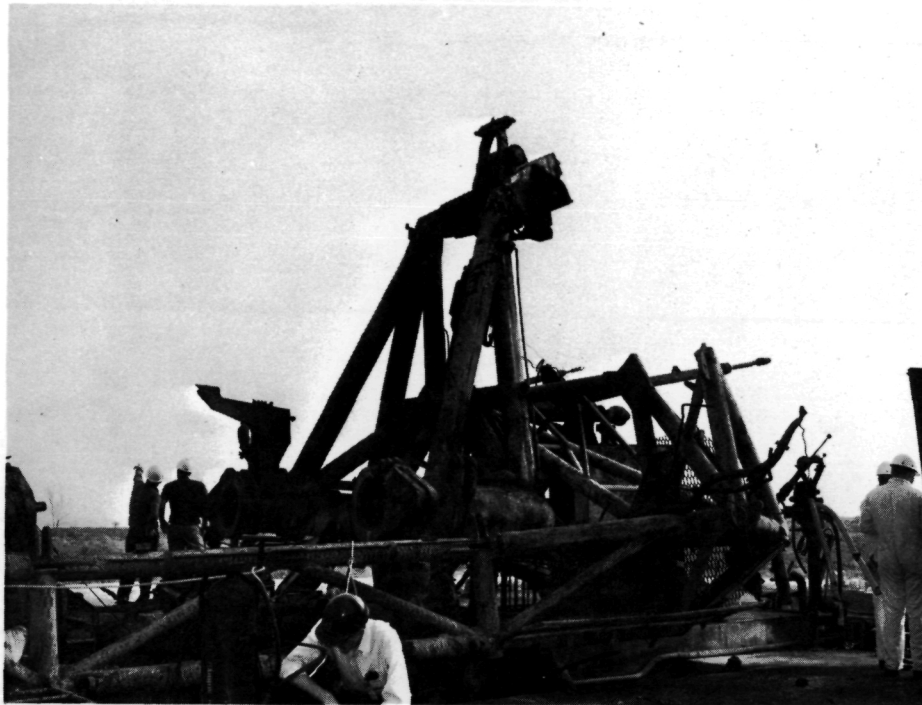
Figure XII-8. - Closeup view of damaged Atlas-Centaur launcher.

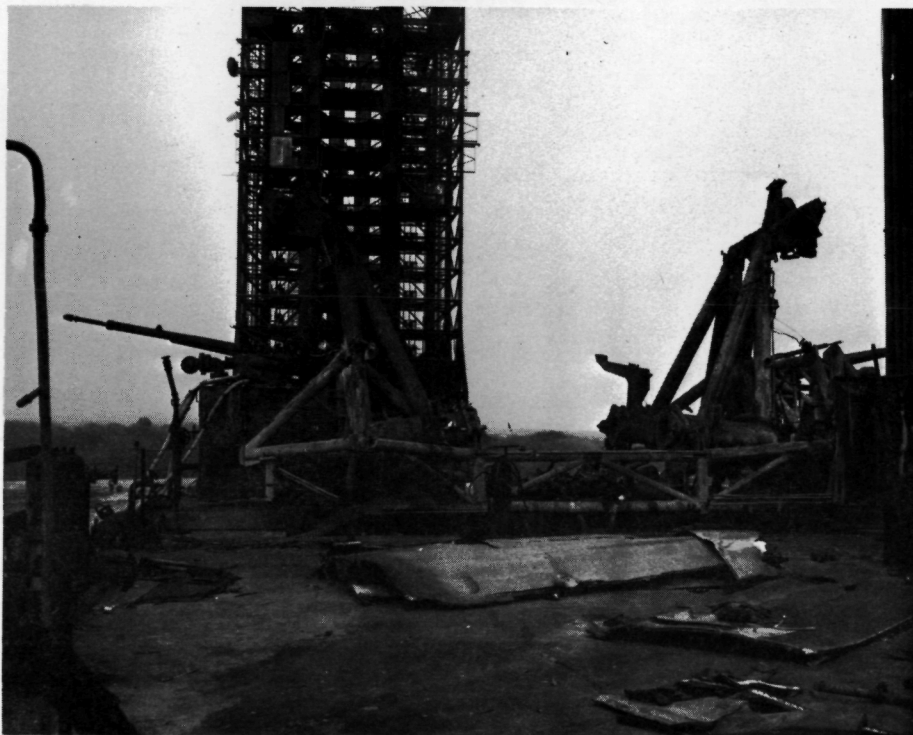
Figure XII-9. - Damaged launcher with vehicle debris in foreground.
